Identifying Unidentified Repeated Failures

Root cause analysis through digital reliability services

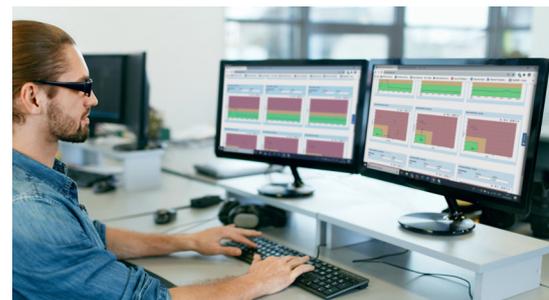
ERIKS Digital Reliability Services installed 12 wireless Bluetooth sensors on the three problematic machines, enabling them to monitor the condition of the pumps. After only a few weeks of testing, the condition of one of the assets was deemed critical, with automated analysis identifying the root cause of this recurring problem – looseness within the machine structure due to improper installation. Shockingly, the simplicity of a loose flange mounting bolt was causing excessive vibration, leading the asset down a path of certain failure.

Vibration analysis undertaken to identify root cause of recurring problem

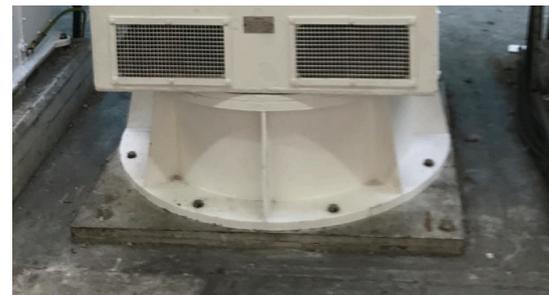
Best case scenario would have landed the customer with a bill of £80k for removal and overhaul, while if left unattended, costs would of hit a staggering £240k with serious damage to the civil infrastructure, motor, commutator, seals, pump and internals, with many of the components requiring reverse engineering due to obsolescence.

Excessive vibration due to loose flange bolt. 1/2 turn achieved on rear bolts, 2 full turns on front bolts

With the problem highlighted, the customer was able to recitify the issue, simply by tightening the rear bolts by half a turn and the front bolts by two full rotations.
