# ERIKS Complete Package Gets Ferry Back on Track

From enquiry to redesign through to commission

**Ferry Port Gantry Sheaves**

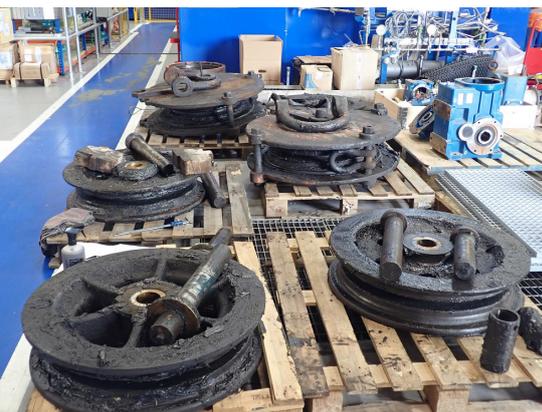
With one vessel [from three] already out of commission due to a scheduled 14-week overhaul, an inspection of the gantries at either end of the port reported some unexpected wear on a selection of the pulleys.

Worn pulleys at Plymouth Service Centre

Following consultation and site visits with the customer, it was concluded that the pulleys required replacement to ensure that the ferry could be safely operated when docking into each terminal. As a public service, passenger safety is paramount and the main consideration whenever in operation, therefore highlighting the issue and devising the right plan of action was essential for protecting terminal staff and ferry users.

All relevant risk assessments were then completed, before the sheaves were removed, collected, checked, and transported to the ERIKS Plymouth Service Centre, where strip-down and inspection commenced, along with measurements taken and recorded.

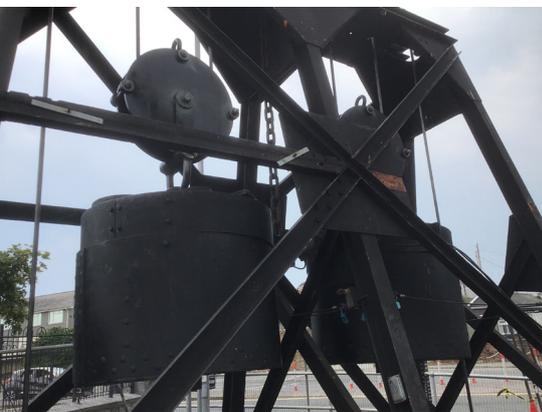
Gantry sheave in-situ

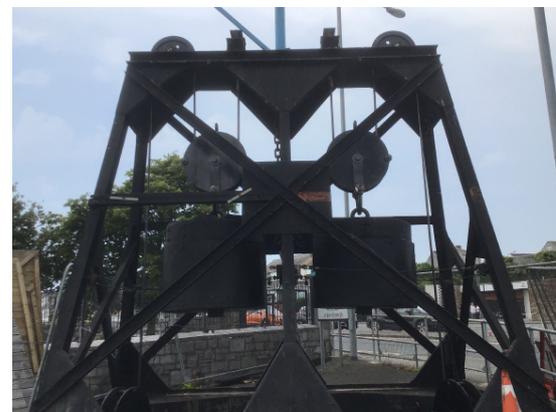
New gantry sheave re-installed

The engineering work got underway, with the detailed scope of the project including: in total 12—off various sheave assemblies designed, drawn and manufactured, comprising of shafts, SAE phosphor bronze bushes and thrust plates, shrouds, pivot arms, and HD bolts. In addition, special heavy-duty Dee and Bow shackles were designed and manufactured, which would all work together as one fluid mechanism to provide complete control and balance of the vessel as it glides across the water.

With all engineering work completed, to the joys of the terminal management team and local community, the new sheaves and pulleys were transported back to site before being re-installed and commissioned. Service had been returned to full capacity, significantly reducing the current delays.
