A Fenner Solution to Secure Pulley Shaft

ERIKS identified and rectified pulley shaft fixing for customer using Fenner

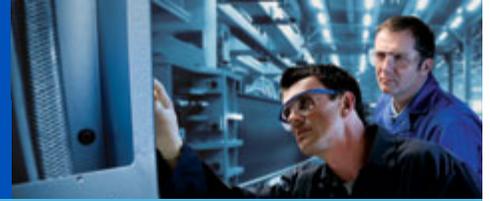
A packaging material manufacturer in the North of England had a problem with a gearbox pulley arrangement which drives a carriage.

The drive arrangement experiences frequent stop/starts and direction changes. This arduous duty cycle was causing the pulley mounted on the gearbox shaft to slip and lose drive synchronisation. The pulley had been secured to the shaft by means of a taper bush, but this was not proving satisfactory.

ERIKS were contacted and proposed an alternative method of securing the pulley to the shaft. A new pulley was supplied and machined to suit 2 FenLock keyless shaft fixing devices. The FLK133 version has a locating collar which allows precise positioning of the items inside the machined bore of the pulleys.

The new pulley and FenLocks were fitted to the existing gearbox shaft and there is now trouble free operation with no backlash or slippage.
