Halloween horror averted with ERIKS speedy response

Six day turnaround avoids six weeks' lost production

Application:
Cement Raw Mill Motor

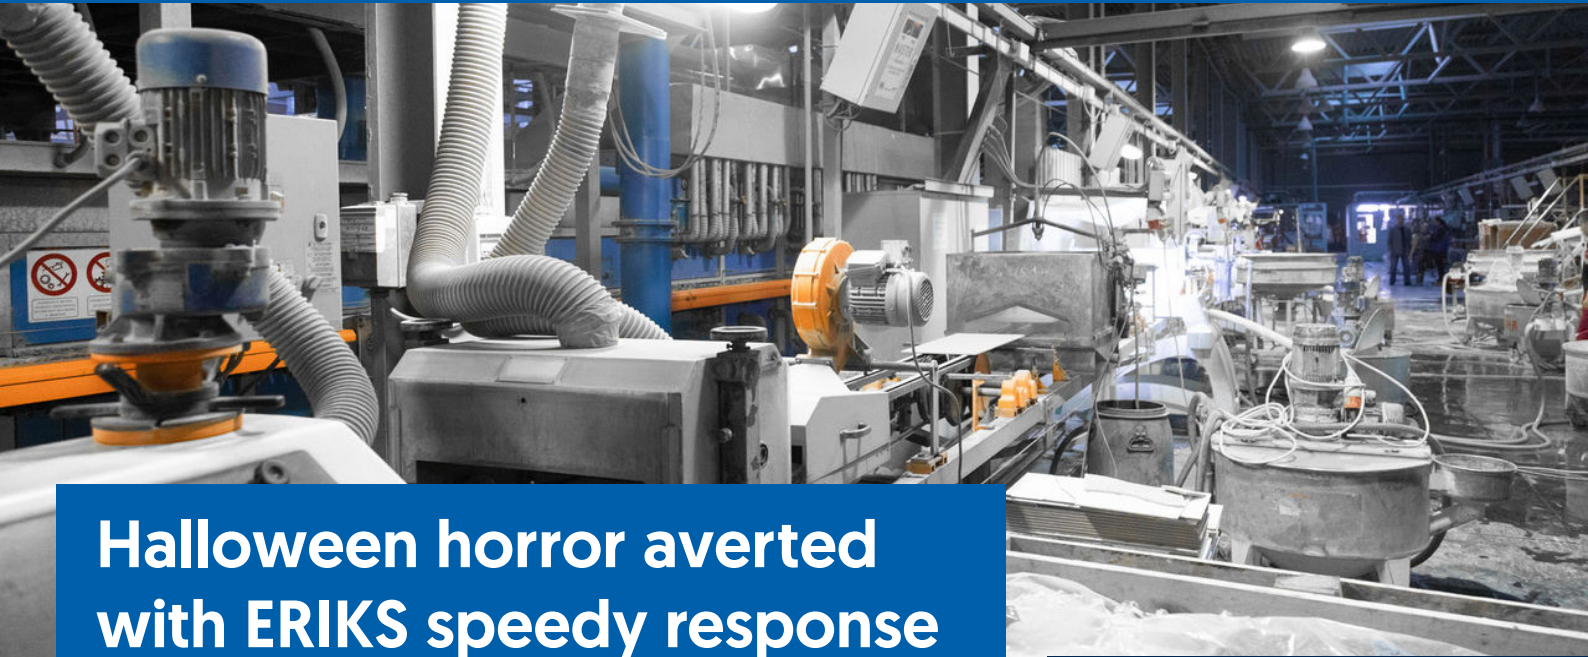
Next, they removed the brush gear to gain full access to the slip rings. This very quickly showed heavy carbon contamination along with substantial burning and pitting of the slip ring contactor surface. With just two weeks supply of raw material stockpiled, salvaging the slip rings was essential.

The slip ring repair and motor rebuild comprised cleaning, polishing, and skimming the slip rings. In all, it took 343 working hours, including engineers' time on site, working through the day and night at the workshop, and reinstalling the motor back on site once the work was done.

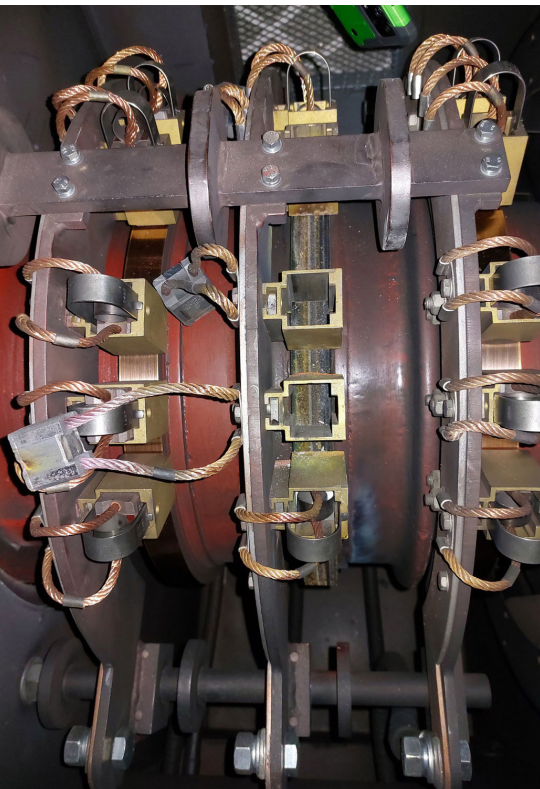
Raw mill motor slip rings

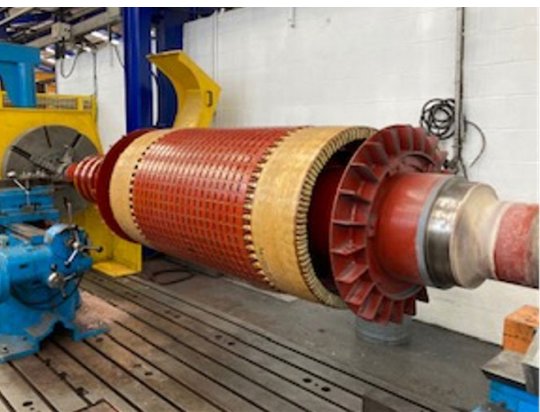
ERIKS engineers were on site the same morning. Their initial investigations revealed damage to the motor's brush assembly and slip ring contactor collection surface. They performed a Baker Surge Test in-situ - a test that is ideal for motors that are difficult to remove, or those that are critical to operations.

Raw mill motor in-situ

The ERIKS engineers quickly got to work cleaning and repairing the rings in-situ, carrying on the next morning, 1st November. The motor was tested that afternoon, but the engineers decided further investigation was needed. For optimum safety for all parties, this was to be carried out offsite, at ERIKS' Chesterfield workshop.

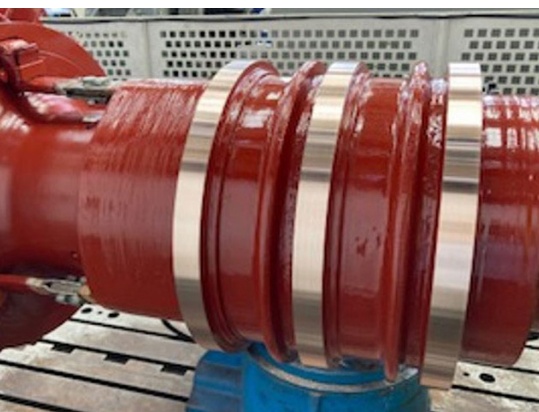
Raw mill motor back in-situ after rebuilding

Thanks to good planning and the expertise and know-how of ERIKS engineers, the slip rings were repaired in double quick time. A successful test run was carried out on 4th November and by Bonfire Night — six days later and three days ahead of estimate — the motor was back in place and the raw mill ready to roll again.
