# Case Study

## Primary Settlement Tank

ERIKS repairs failed Primary Settlement Tank for a major sewage treatment facility in London

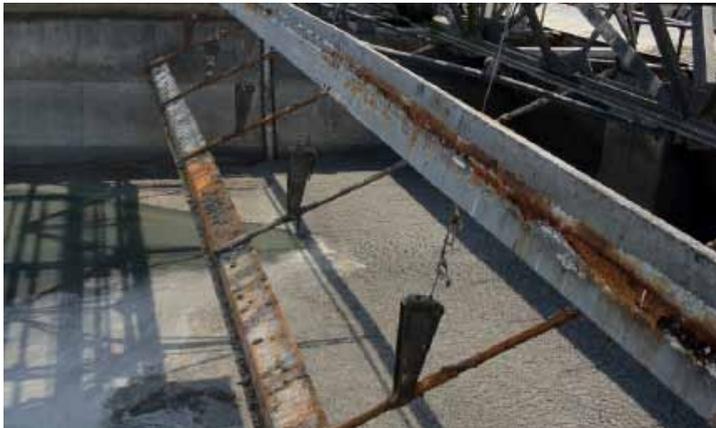
A Primary Settlement Tank (PST) failed at a major sewage treatment works in London leading to the settled sludge process halting on the tank in question.

This led to inverted sludge developing on top of the tank and effective sludge removal not able to be removed as a part of the treatment process.

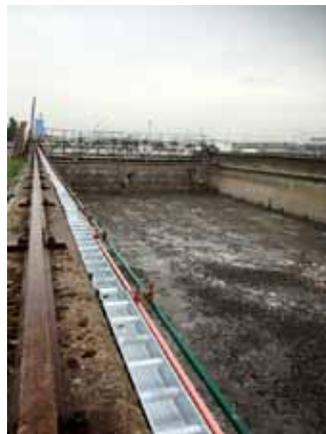
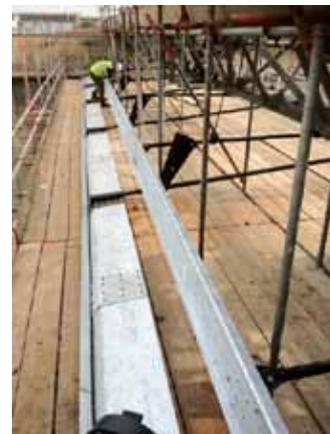
Once fabrication of the components was completed then the removal of the bridge components was carefully planned and co-ordinated using fully Insured Scaffolding & Contract Lifts in order to remove the heavily weighted shafts, scrapers, wheels, gearboxes and motors.

After the Risk Assessments & Method Statements for the mechanical work, scaffolding, site traffic management and the lifting plans were approved ERIKS were then able to co-ordinate the site attendance and removal of components.

Fabrication of all materials took 1-2 months and ERIKS were then able to return to site to install the newly fabricated components as required and re-commission the bridge.
