Case Study

Marine Swing Up Thruster

Onboard survey involving expert Condition Monitoring staff

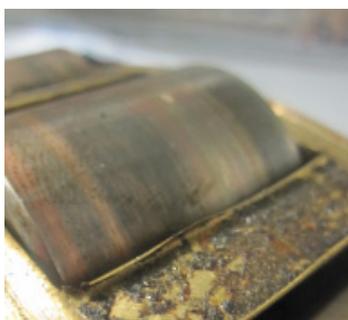
Further discussions highlighted the bearing had only been replaced a matter of months ago and had previously only lasted a matter of hours after major overhaul.

Bearing images of initial failure after a matter of hours

It was decided to uncouple the drive motor from the Thruster for investigation, on dismantling the coupling it was found that the coupling assembly had not been carried out correctly nor had the correct amount of torque applied to the fixing bolts.

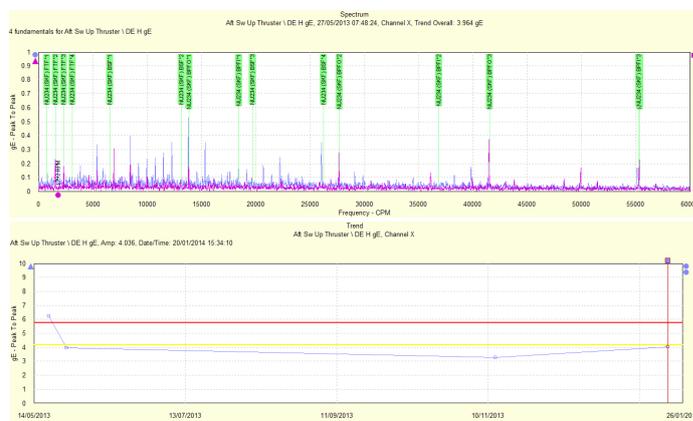
Once the coupling was re-assembled as per OEM specifications further vibration testing was carried out and highlighted a drop in overall amplitudes and fault frequencies.

Vibration spectral and overall data before and after investigation and repair

Since the initial survey further scheduled monitoring of the thruster has revealed that the vibration signature is remaining steady and there has been no further increase in amplitude of the fault frequencies.
