## Rotary Bio Centrifuge Failure on Sewage Treatment Plant

ERIKS replace corroded main frame resulting in significant savings

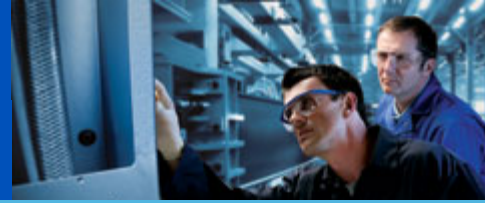
A large Utility company were faced with a corroded main frame which had caused the RBC (Rotary Bio Centrifuge) to fail on their packaged sewage treatment works. This failure is critical on a packaged works, as no other treatment can continue if one section of the works fails.

ERIKS Specialist Engineering Project Engineers cut out the corroded frame in sections. They used the old frames as a pattern to fabricate new frame sections and media support bars at ERIKS Greensford site. These new frame sections were installed in situ.
