<b>Industry:</b>	Metals
<b>Application:</b>	Long Travel Crane Drive Unit
<b>Actual Saving:</b>	£n/a
<b>Payback Period:</b>	n/a

## Gearbox Repair for Loading Crane

ERIKS ensures drive unit is repaired in time for consignment delivery

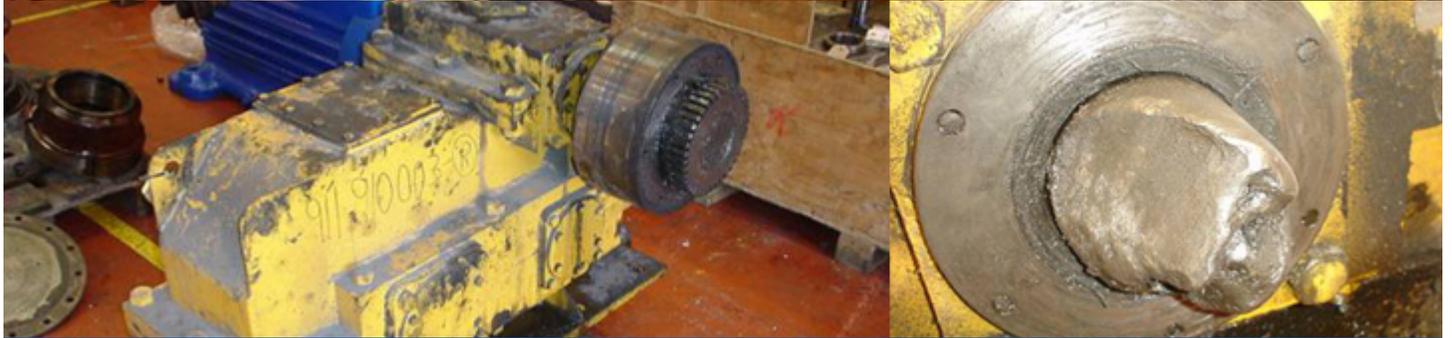
The customer, a large steel producer, experienced a failure on a gearbox on their long travel crane in their loading bay. The drive unit had been overloaded whilst in the process of moving some product around the bay. The load had become unstable and put added strain onto the drive unit; with the added loading the input pinion drive shaft sheared and separated from the drive.

ERIKS collected the drive unit from site and returned it to one of their Repair Workshops in Dudley. On a strip down inspection ERIKS found that the input pinion drive shaft had sheared and broken in two. The drive unit was no longer available to purchase and spares were no longer manufactured by the OEM. ERIKS were able to fully assess the drive unit and offer recommendations to the customer.

ERIKS in-house gear manufacturing and repair facility were able to offer the customer the solution to fully overhaul the drive unit, which included manufacturing a new set of primary gears to suit the drive. The unit was fully overhauled and returned to site prior to the shipment of product arriving so the customers engineering team were able to reinstall and commission.
