Industry:	Mining and Quarrying
Application:	Rock salt mine
Actual Saving:	£undisclosed
Payback Period:	<12 Months

Weather Resistant Sealing Solution from Revolvo

Increases plant productivity and efficiency

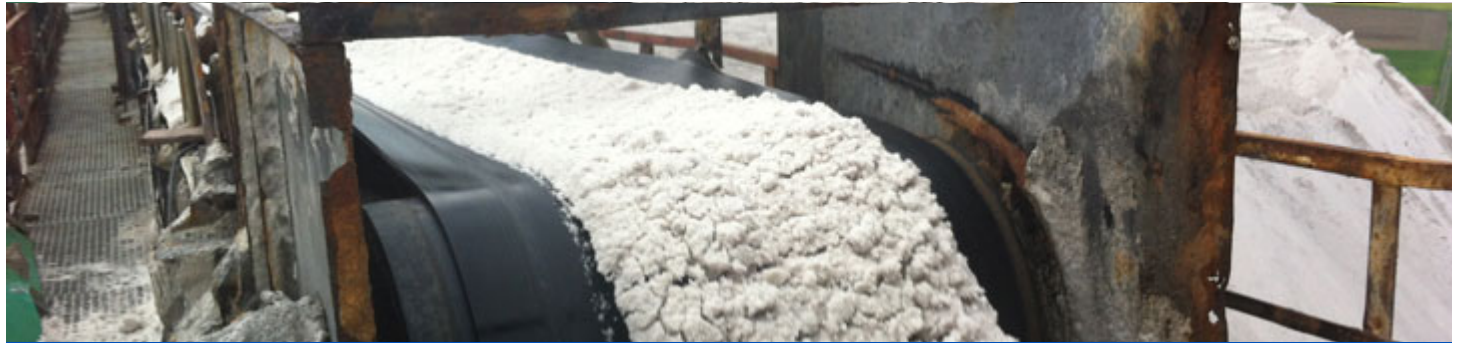
A site visit of the conveyor systems confirmed the bearing failures were due to poor sealing. In addition to this poor access to bearings meant the removal of power transmission equipment to remove & replace bearings.

A pair of bespoke Revolvo Split Roller Bearing units complete with a triple Kevlar Gland Packing Seal arrangement, blanking plate and stainless steel fixings meant a more weather resistant unit. These were designed, manufactured & mounted by Revolvo in 10 weeks from receipt of order.
