PROBLEM SOLVER

PROTECT PRODUCTION FROM PREMATURE FAILURES

Paper and
Packaging

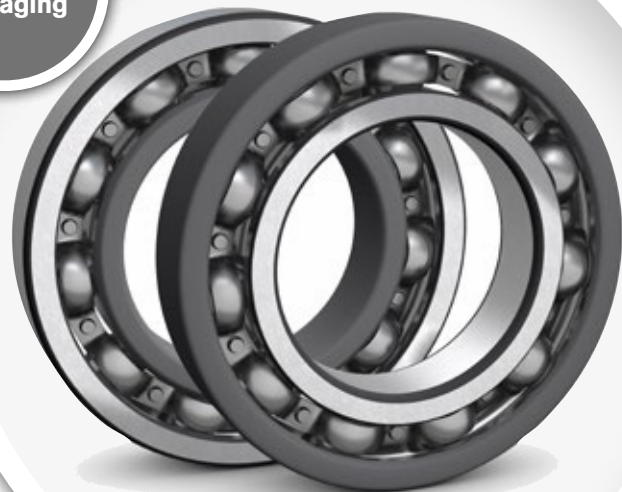
Problem: A leading international manufacturer of heavy-duty carton-board was experiencing problems with the drive motor on its large flue gas recirculation fan. The bearings were failing after only six months, leading to unplanned downtime, and high maintenance and repair costs. It was found that the bearings were failing prematurely due to stray electrical currents introduced into the bearings from the variable frequency converter.

Solution: The maintenance department decided to install **INSOCOAT electrically insulated bearings** in the motor. These bearings come with a sealed coating of aluminium oxide that provides a high degree of electrical insulation. Applied using a sophisticated plasma spray process to either the outer or inner ring, this coating means that bearing failures caused by stray electric currents are virtually eliminated.

After installing INSOCOAT bearings, the producer didn't suffer further bearing failures in the hot gas fan for over five years. In addition, the frequency drive can now be used to its full capacity and they've realised total savings of £250,000.
