Summary

Industry:	Pharmaceutical
Application:	Centrifuge
Actual Saving:	Batch losses eliminated
Payback Period:	Immediate

Sealing Solution Designed and Manufactured by ERIKS

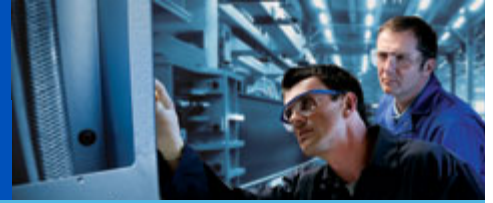
The production process of a large pharmaceutical manufacturer involved the use of a large centrifuge which opened and closed numerous times during its operation. The seal fitted to the unit ensured containment, however, in its closed state it had failed contaminating production resulting in loss of production batches.

Following an initial examination, it was discovered the failure was due to inherent properties of the solid core O-ring. It was determined that the compression led to deformation and material memory returned to its original form. When the seal is in operation, deformation drives the forces that push the material onto the surfaces, causing it to extrude and fail.

Following further examination, ERIKS offered two specially designed perfluoroelastomer (FFKM) profiled seals. The recommended seals had larger contact surfaces than the original O-rings and would fill the groove to reduce the possibility of product contamination. The design also provided a sharp profile which will help clean the surface of the bowl as it closes.
