# PROBLEM SOLVER

## BORON CUTTER MAKE SHORT WORK OF SPOT WELDS

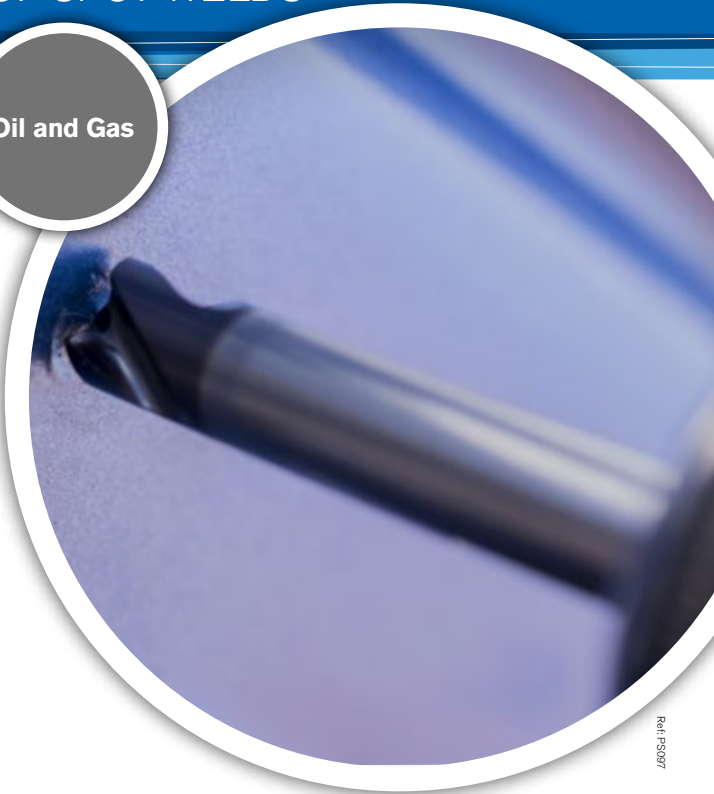
Ref: P5097

**Solution:** A new three cutting edged **Boron Cutter** was developed with multilayer alloy coating technology. This gives the drill bit the ability to cleanly cut through these new materials. Extreme high heat insulation and dispersion characteristics, offer excellent wear, prolonging tool life.

**Problem:** A large fabrication workshop were experiencing problems, when drilling Boron spot welding on cages. It's resistance to conventional cutting tools, such as spot weld drills, and standard cutters etc. were ineffective..

This technically advanced drill is more effective and cost efficient when drilling through these new high strength materials. Correct cutting fluid will also extend the life of the drill bit.
