Case Study

Picket Fence Thickener Failure

ERIKS repairs and redesigns Picket Fence Thickeners with an innovative solution

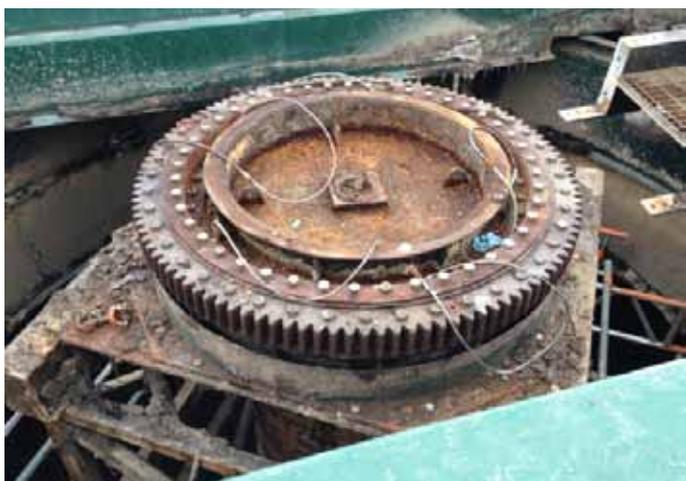
In order to complete this two new supporting spool pieces would need to be fabricated. The existing

driving gearbox was also old and it was recommended to change this to a new planetary drive so as to increase the torque output and efficiency of the unit. The torque limiter was replaced with a new Mayr internally sealed FTL series, with a manual resetting feature so as to avoid tampering of the protection by the operators.

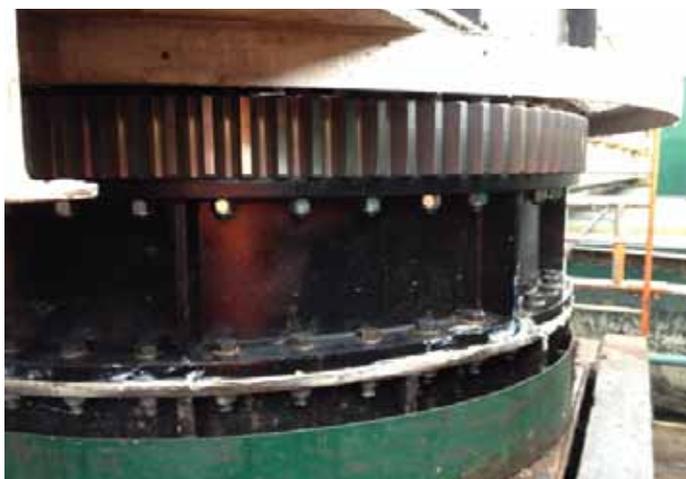
The slewing rings were manufactured and supplied new and the existing greasing system was removed and replaced with a positive displacement powered grease dispenser.

To incorporate the new design the entire supporting structure was required to be raised, a newly fabricated supporting frame was also needed.

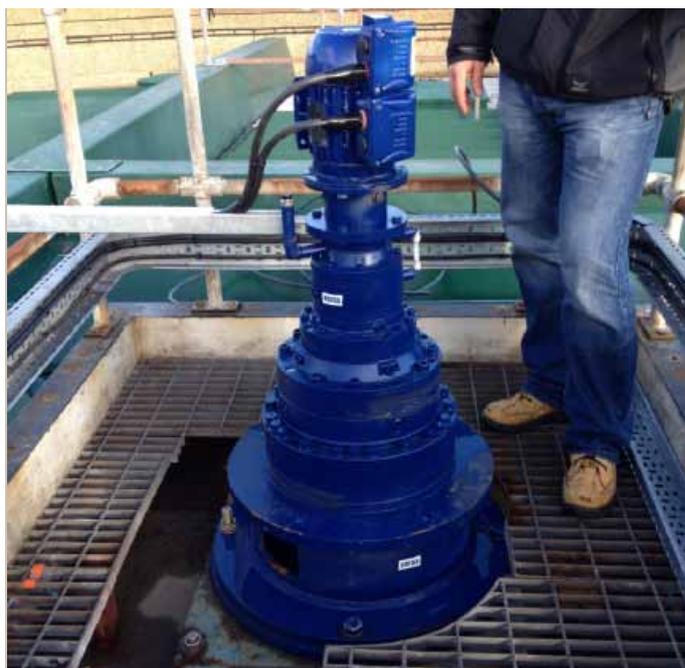
ERIKS removed the existing drive using contract crane lifts, the adaptor plate to mount the slewing ring was also removed and newly fabricated. The new slewing rings were installed by the means of two separate spool pieces designed and fabricated by ERIKS. Once this was completed the newly fabricated walkway structure was placed on top and the electrical connections established along with the lubrication system.
