## Reduce bearing fitting issues with Volcano

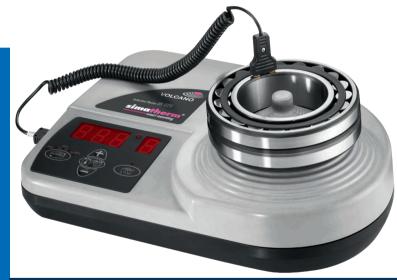
The Simatherm Volcano IH025 weighing just 5 Kg allowed for easy transportability and safer fitting whilst vastly decreasing downtime.
