Industry:	Metals
Application:	575 kw Crane Motors
Actual Saving:	£n/a
Payback Period:	n/a

Steel Dust Ingress Prevented

Improved sealing arrangement, higher insulation specification and rewind

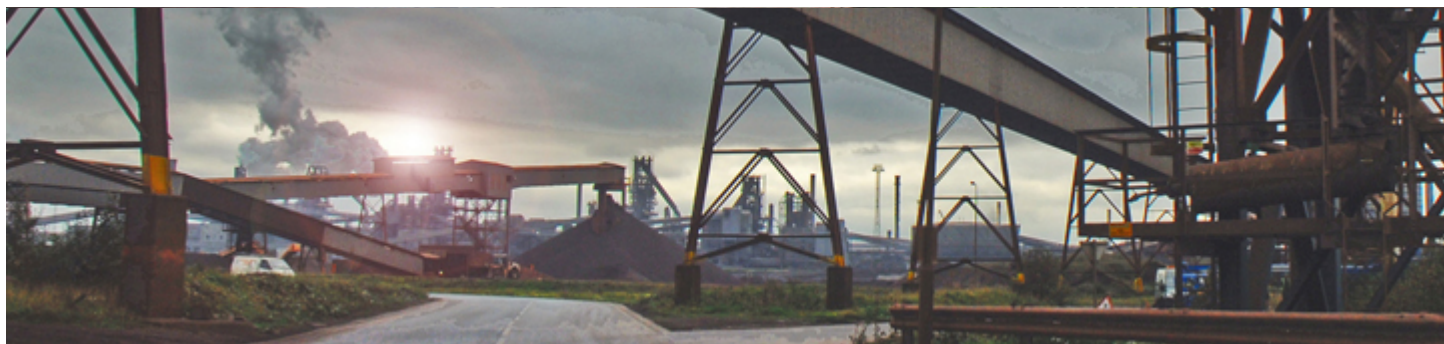
A large steel manufacturer was experiencing problems with a large 575kw crane motor which was failing on a regular basis due to the ingress of steel dust. Historically these units would only last for a period of 3 months after a repair.

Due to the arduous conditions this motor was rewound to a higher winding and insulation specification, incorporating an improved sealing arrangement. The result was the prevention of ingress contamination in the motor which resulted in a significant increase in its life. These motors are now running for periods in excess of 12 months.
