Industry:	Food and Drink
Application:	Lubrication system on crumpet line
Actual Saving:	£n/a
Payback Period:

Crumpet line oil spill solved by ERIKS

Health and safety issue averted by oil flow manifold

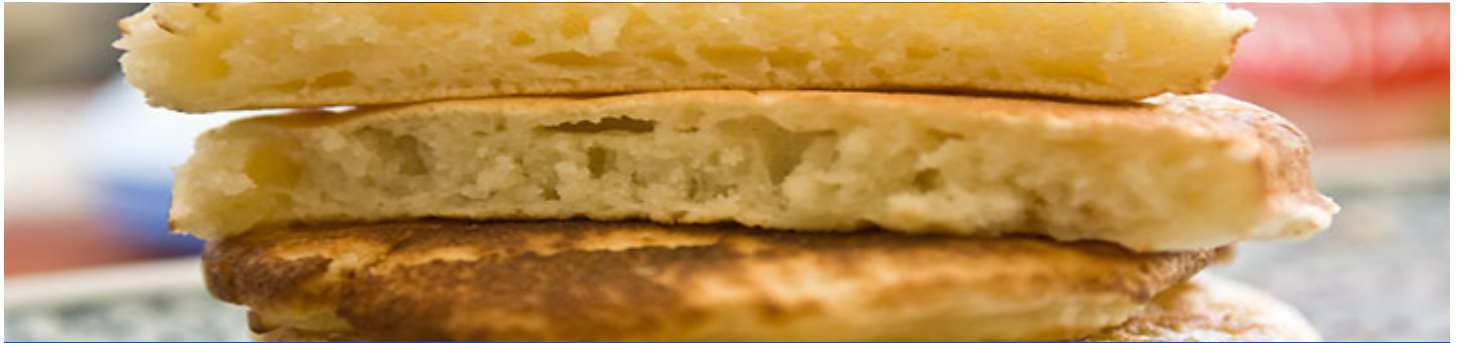
A Northern bakery was experiencing problems on its crumpet lines. Oil was put on the tins to stop the dough sticking while going through the oven. Originally, the oil was literally dripped onto the crumpet rings by a very crude method. Taps from a reservoir were turned on at the start of the shift and left on. However, when the machine stopped, the oil continued to flow and became a health and safety issue because oil spilled all over the floor.

The Engineering Manager called ERIKS in who came up with an automated lubrication system. This system automates this process by being controlled by the machine's PLC, so if the machine stops the oil stops. A new reservoir and control unit was supplied along with a manifold to control the oil flow to the crumpet rings.
